**ESSAR STEEL INDIA LIMITED, PARADEEP**

**Welcome to the presentation  
on the transformer fire incident that took  
place on 25.10.2012 at PELLET PLANT**

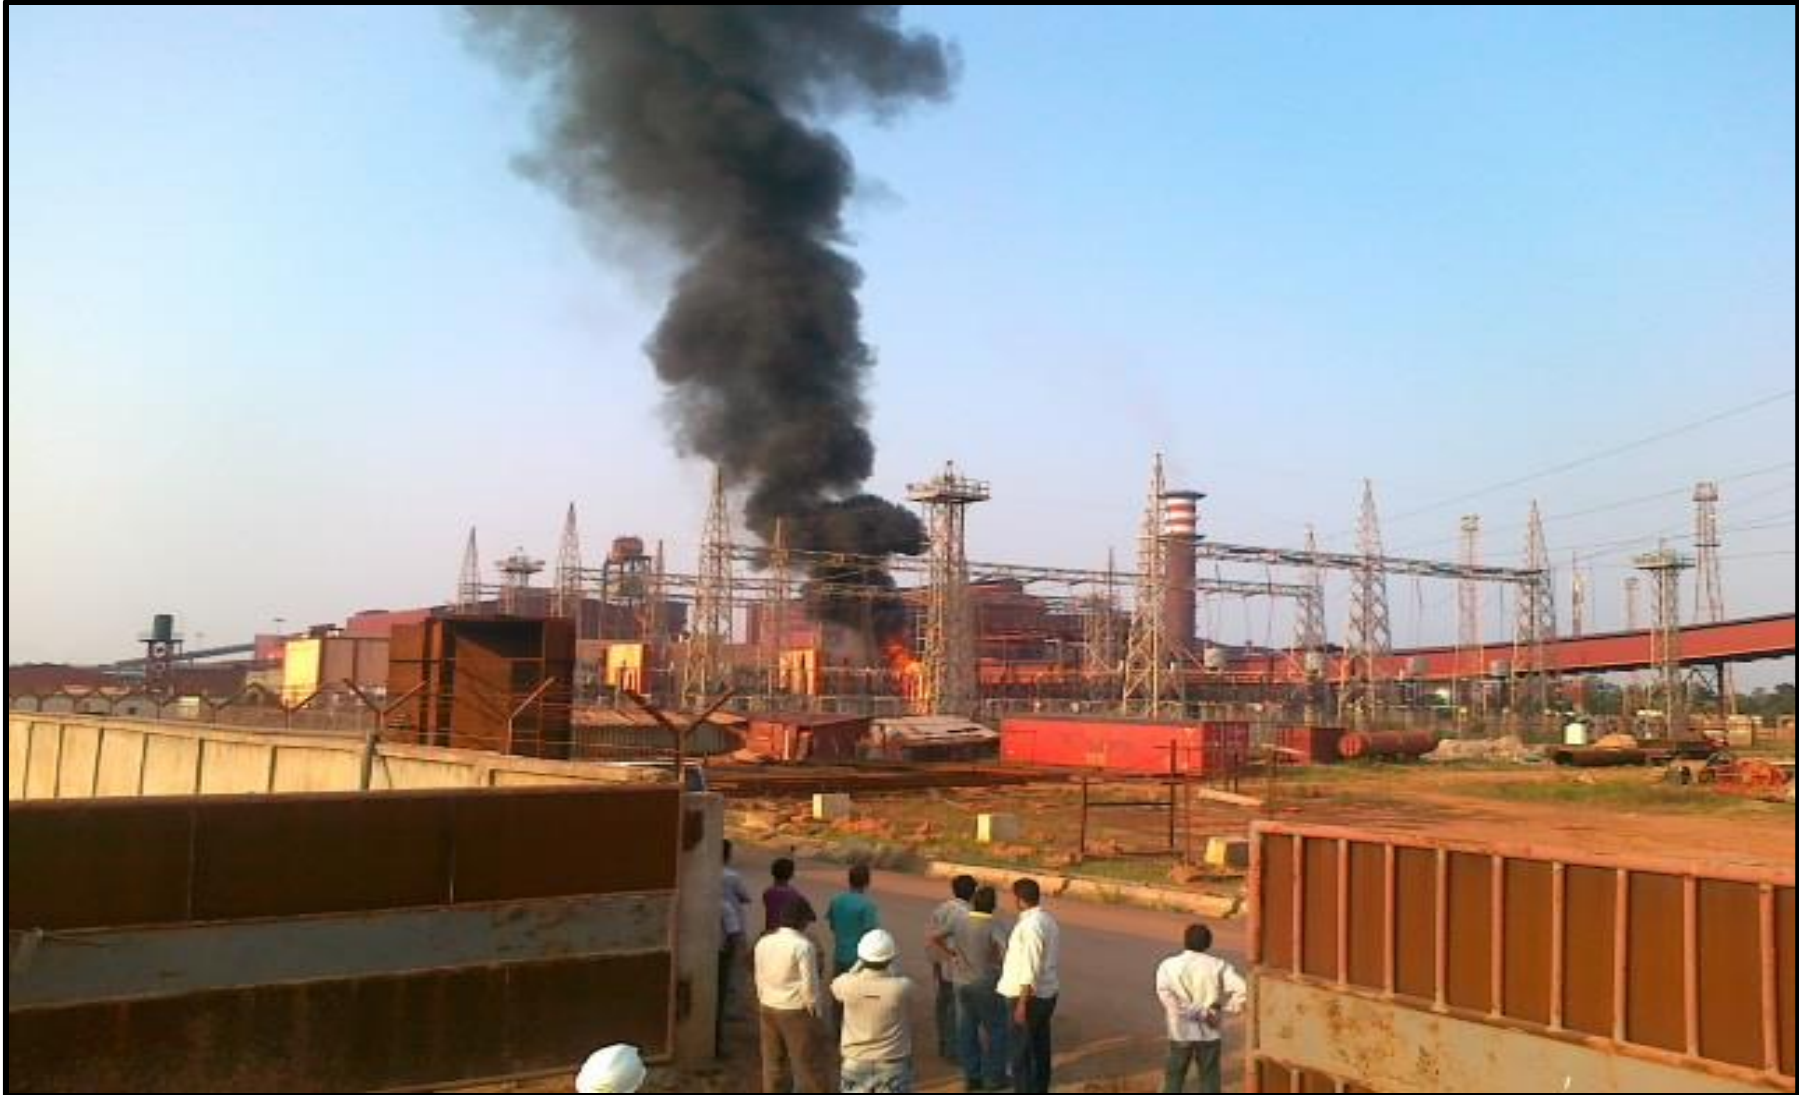
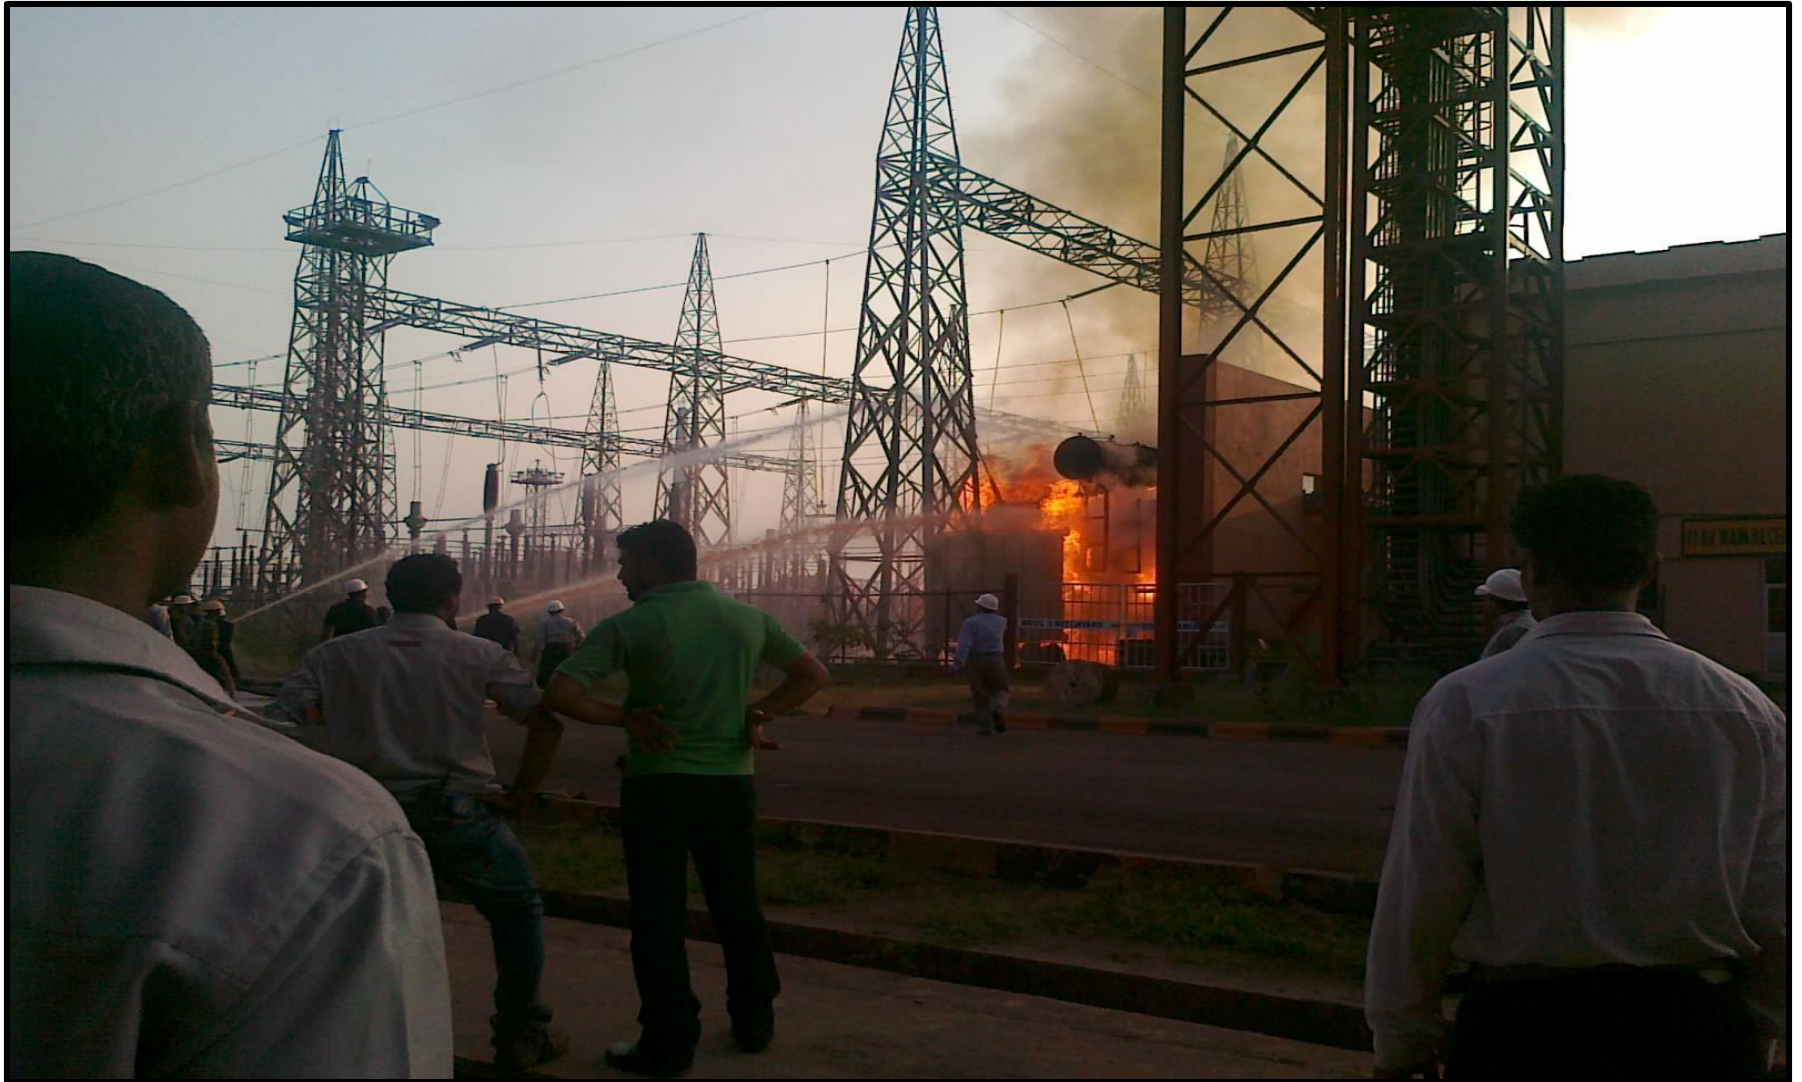
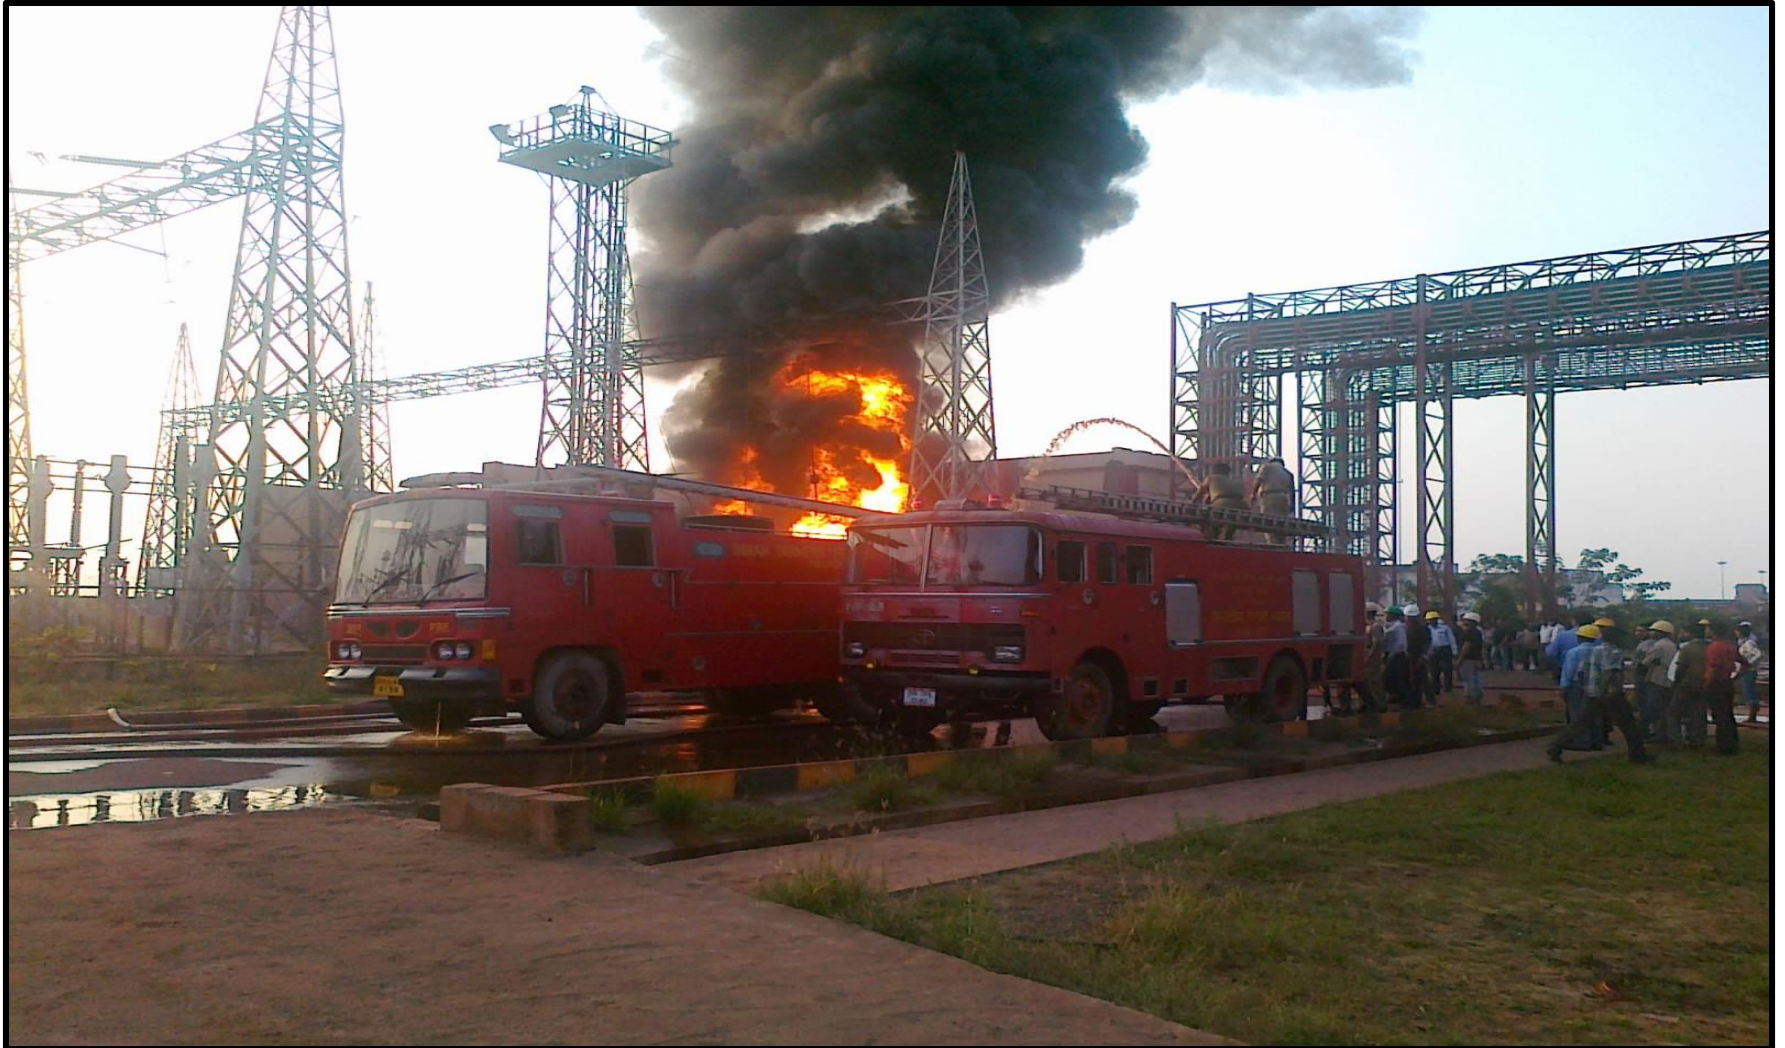
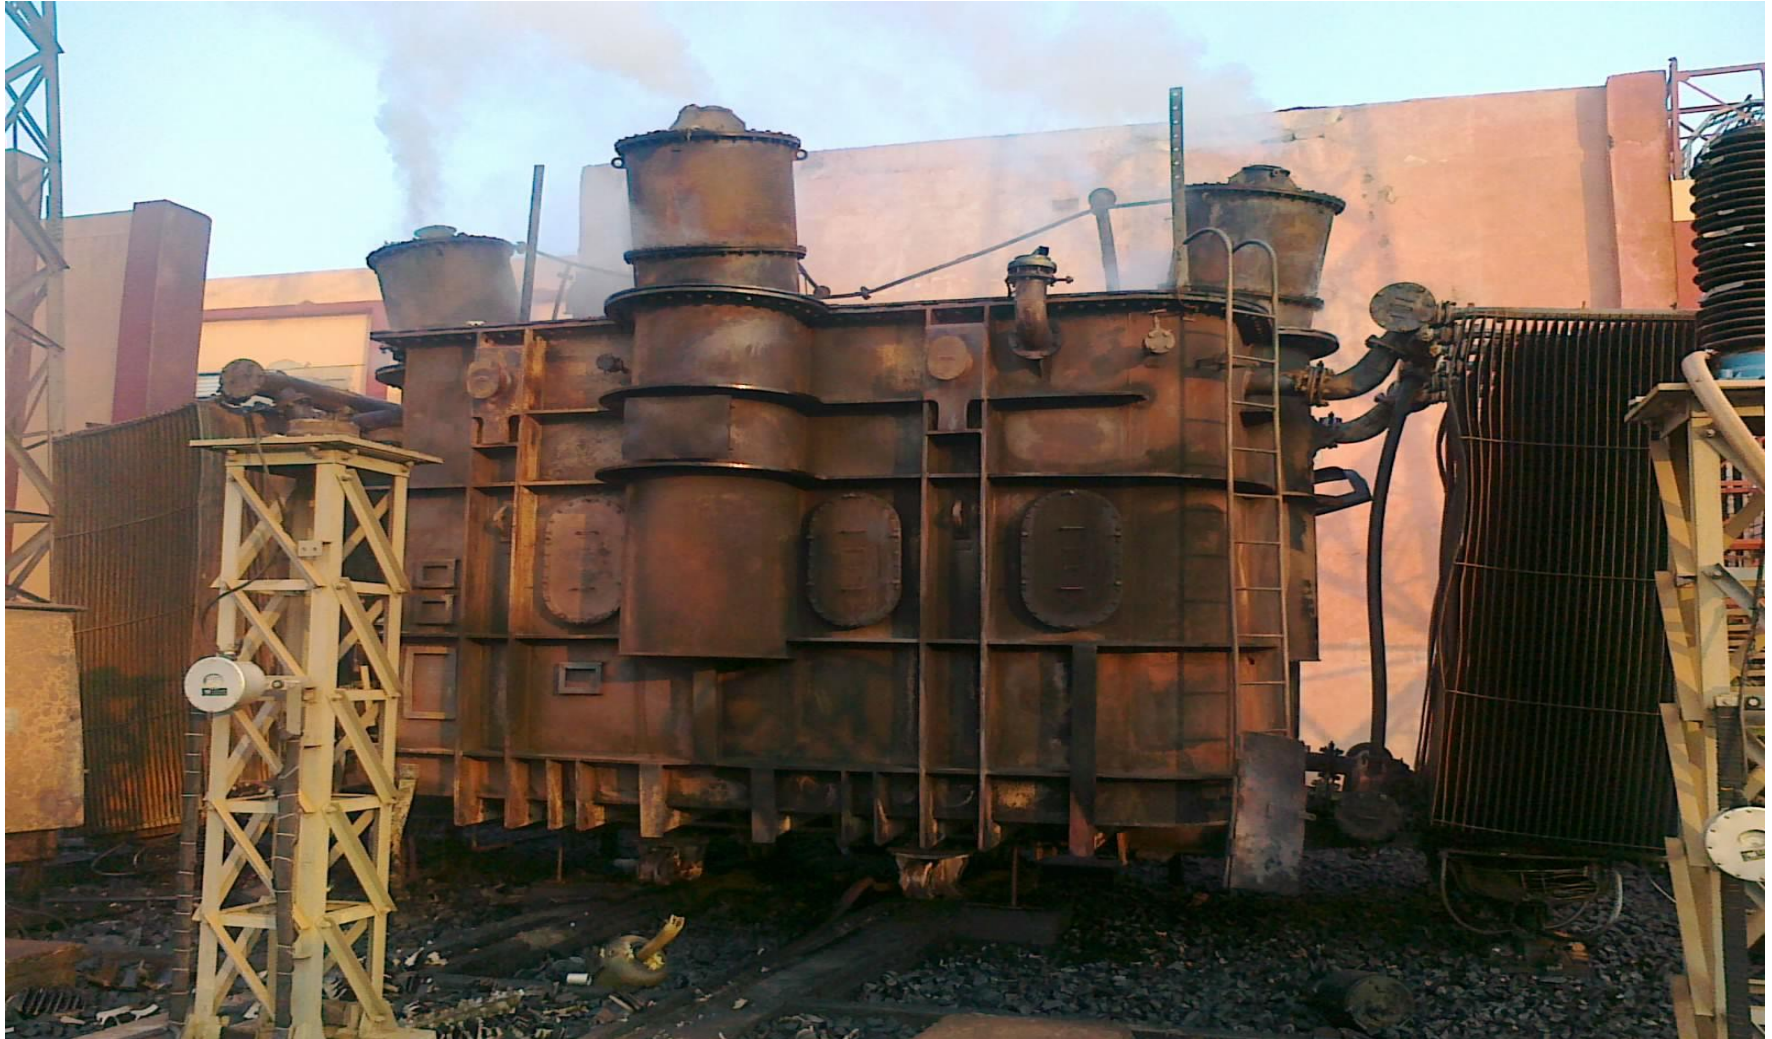
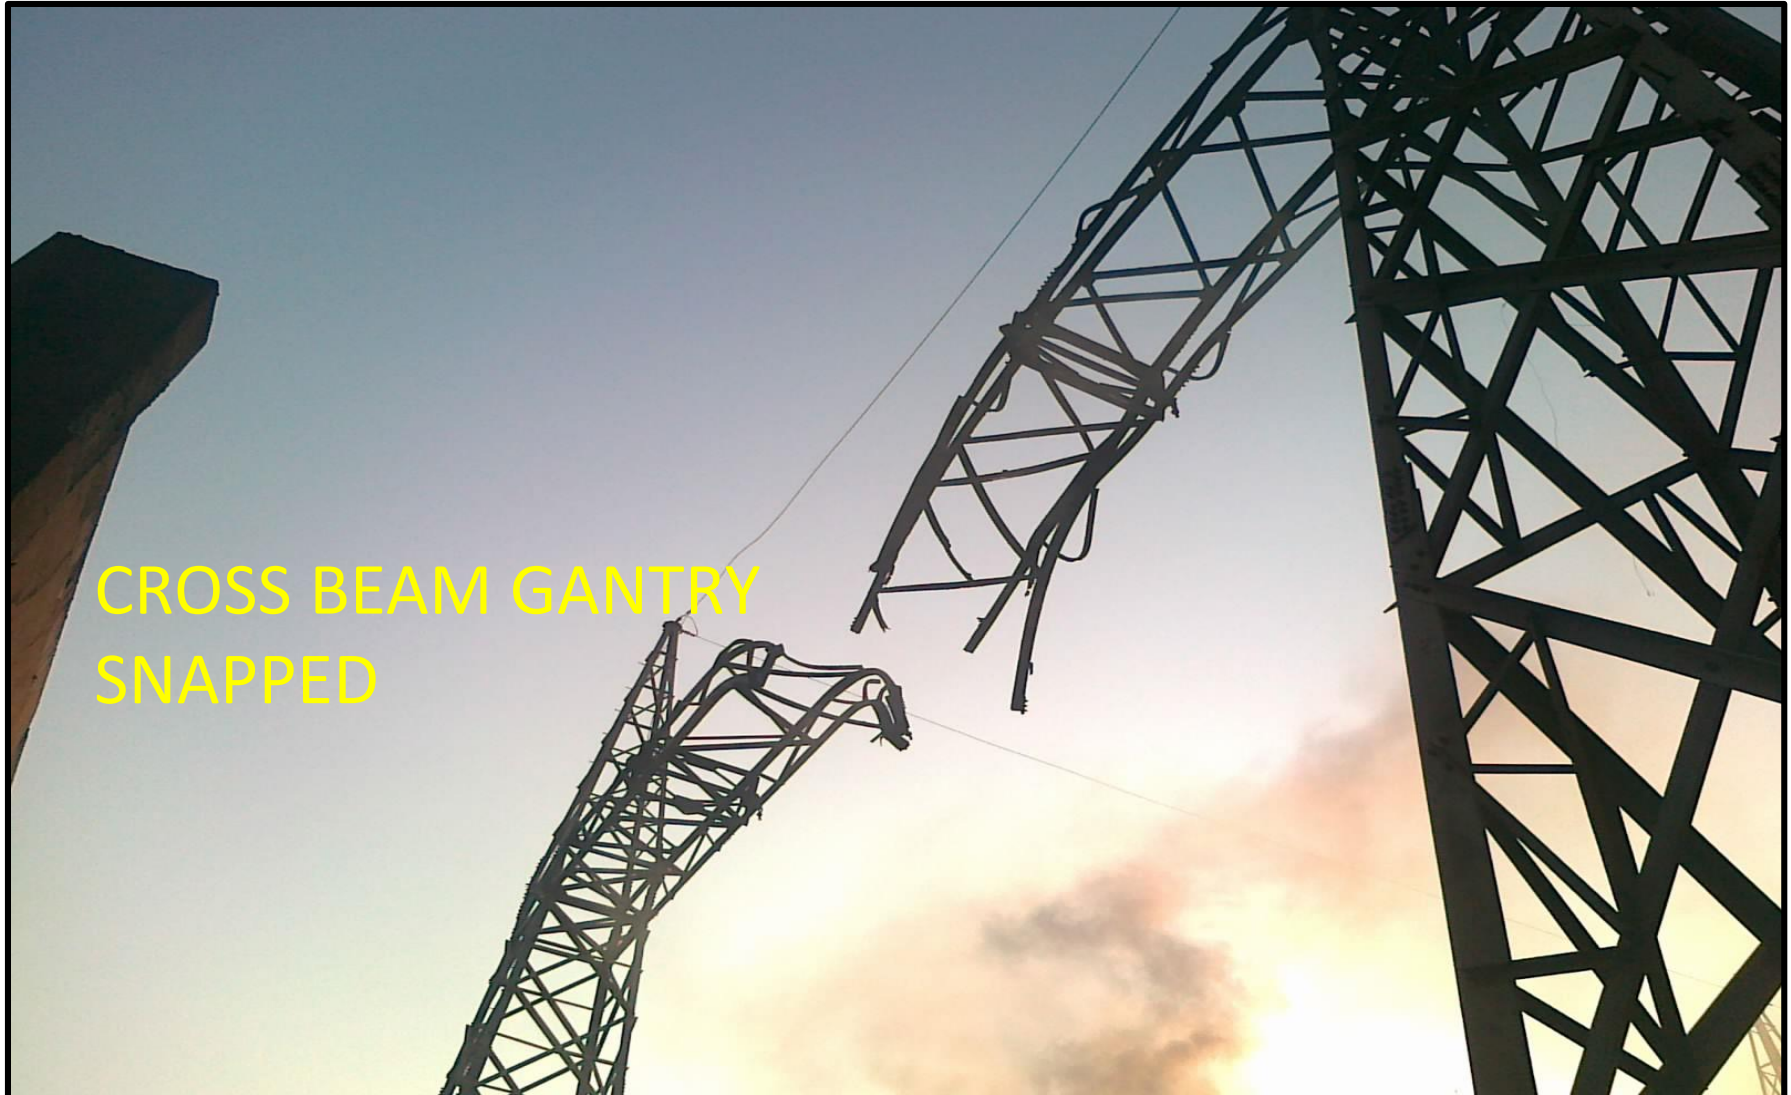
- On 25.10.2012, the oil filled 40/50 MVA transformer no. 1 was operating with a load of 15 MW
- At 15:35 hrs, a sound was heard in switchyard with power failure.
- At around 15:38 hrs, smoke was seen coming out of Y Phase EHV bushing of the transformer followed by Fire
- At around 15:40 hrs, the long rod insulator above Y phase bushing caught fire and conductor got snapped.

- All the associated power and control cables
- Surge arresters – 03 Nos
- Bus Duct – 01 No.
- Neutral Grounding Resister (NGR)– 1 No.
- Snapping of Transformer Gantry Beam
- Long Rod Insulators(LRIs) – 03 Nos

- The supply voltage from OPTCL's GRID at times was exceeding the rated voltage of 220KV by more than 10% (maximum voltage supplied by OPTCL was recorded to be 250KV)
- Failure of Y-phase EHV bushing of the transformer
- Pre-mature failure of winding of the transformer
- Failure of Nitrogen Injection System as it was in by-pass mode.

- Isolating power dips and supply of excess voltage by tripping the OPTCL line breaker and running the plant in islanding mode with our 2x30 MW Captive Power Plant located adjacent to our Plant
- Putting the Nitrogen Injection System in Active Mode and not in by-pass mode.

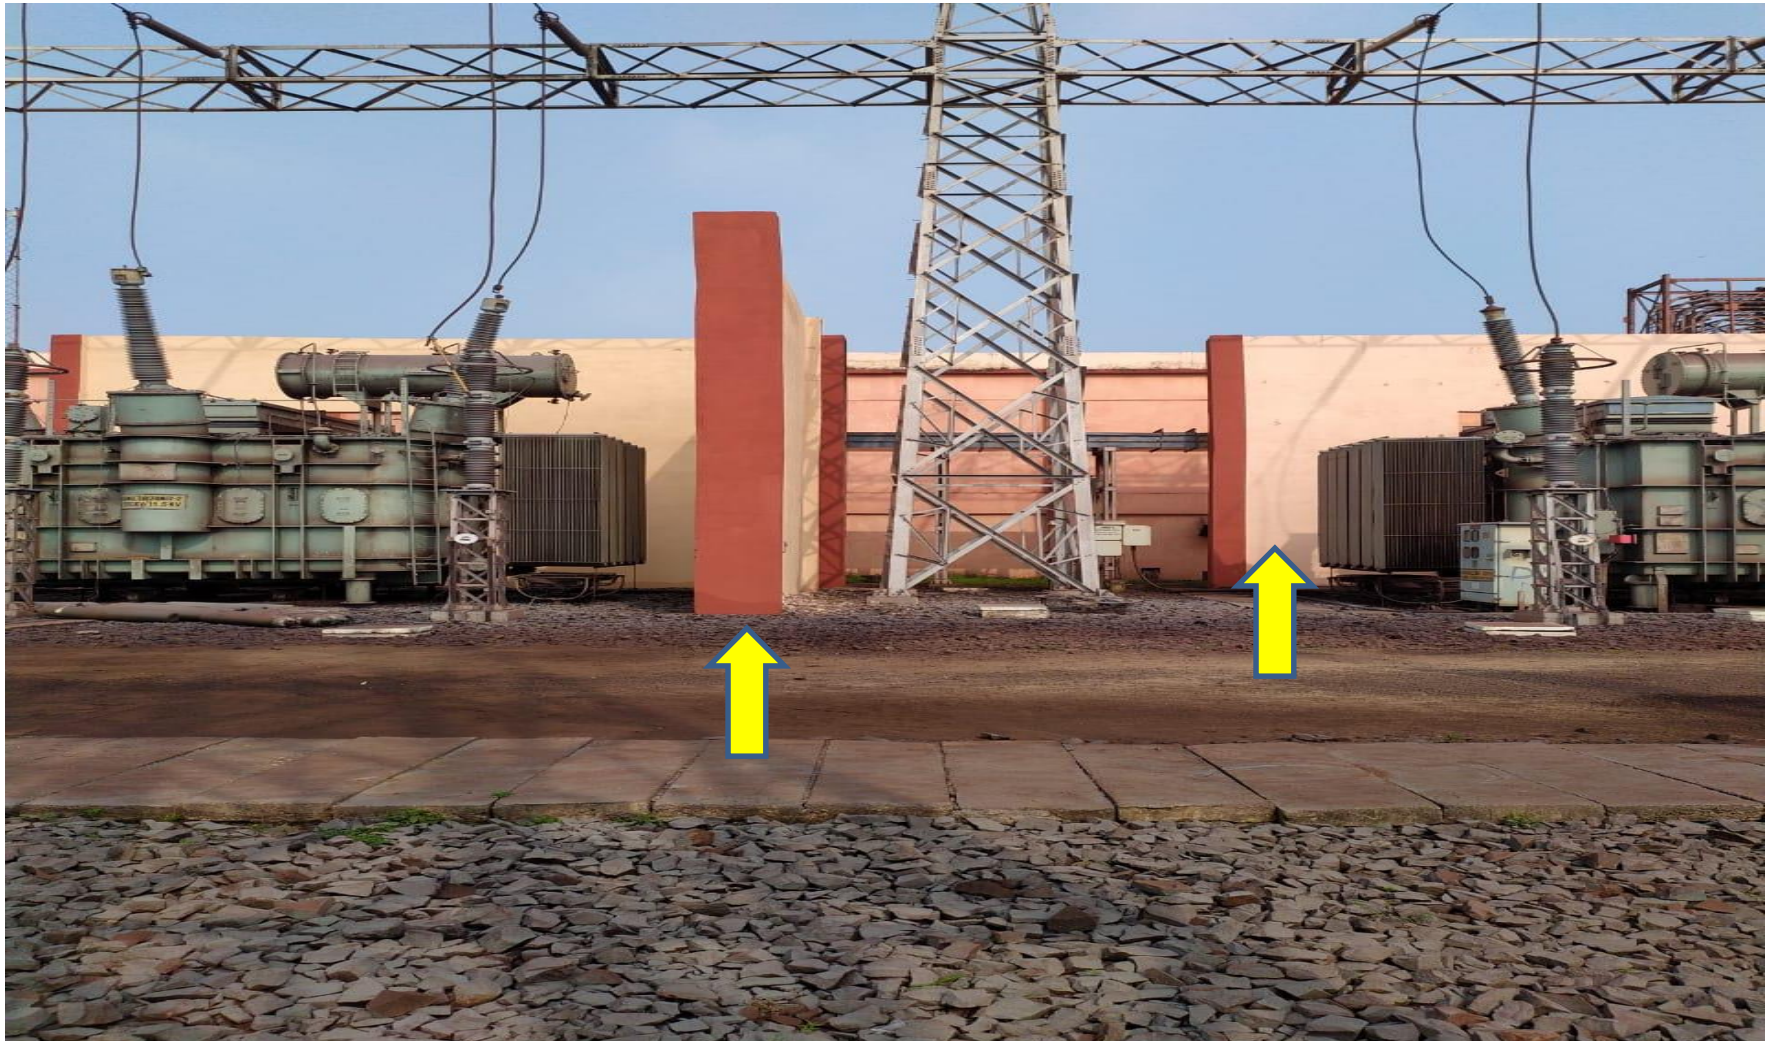
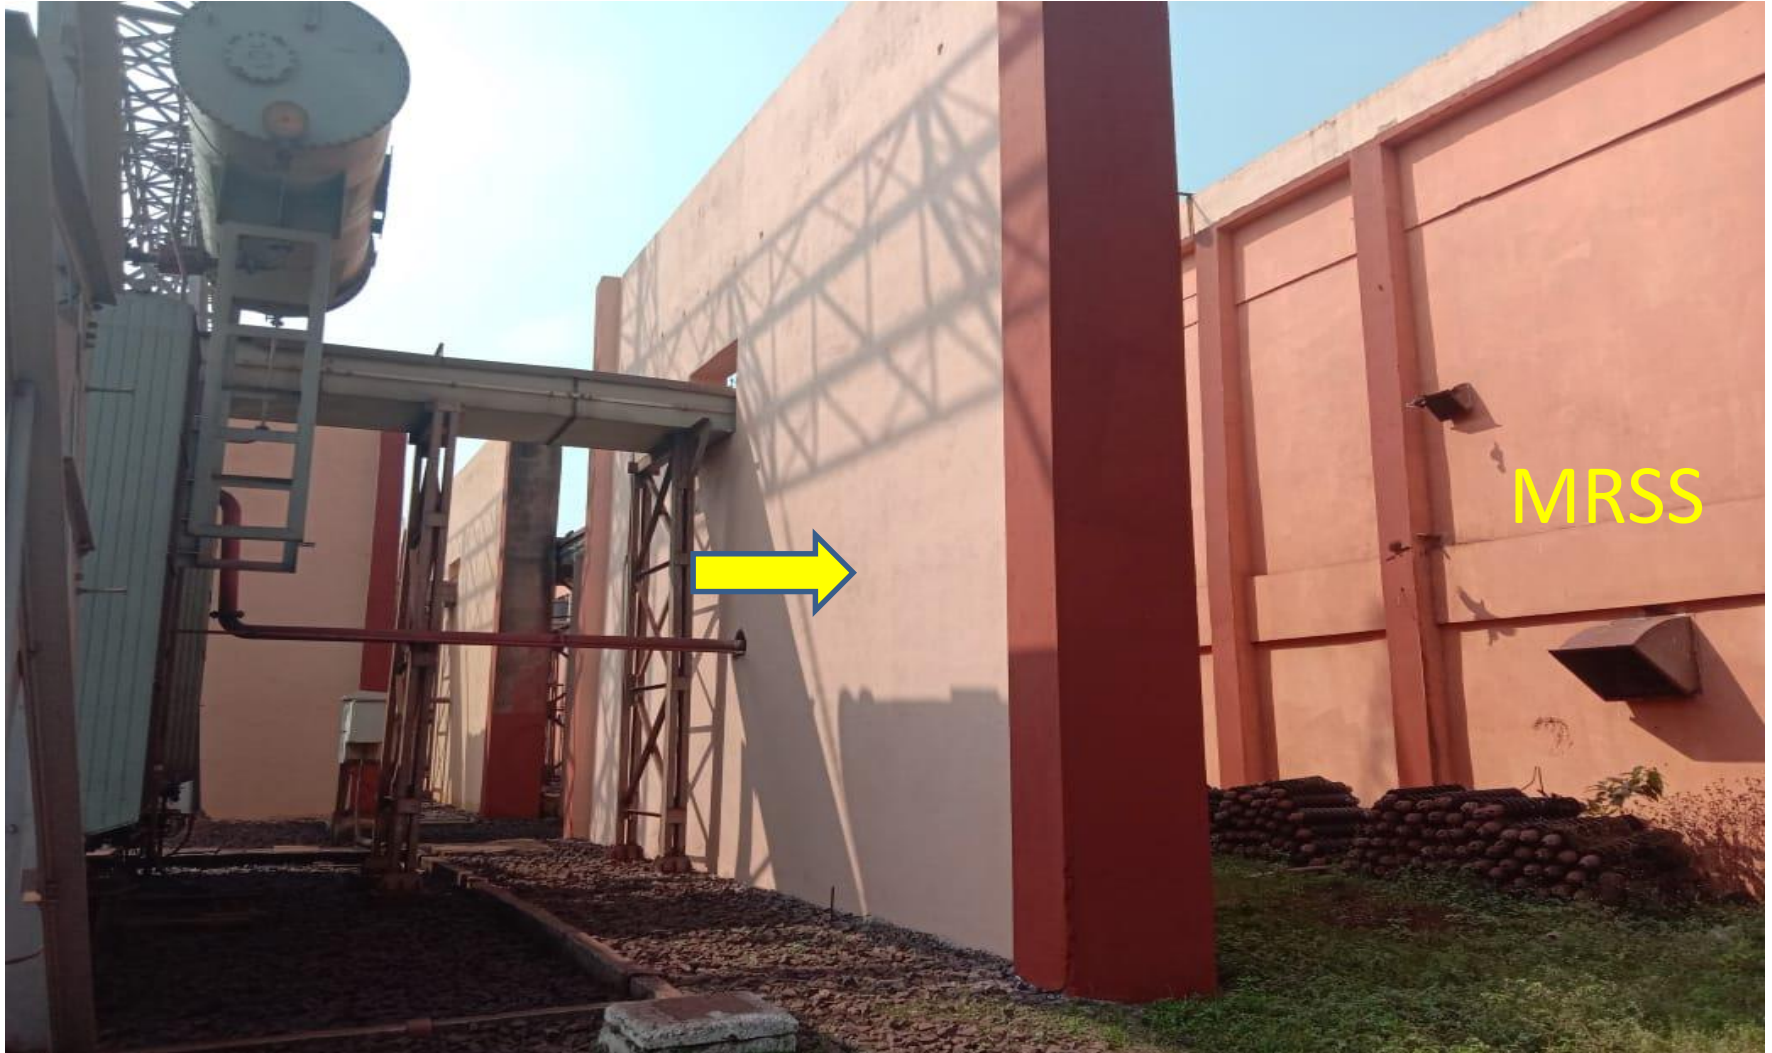
# FIRE WALLS AROUND TRANSFORMERS

N.B : due to the presence of Fire Walls between both the transformers and as well as between the transformer and ECR, extensive damage could be avoided.

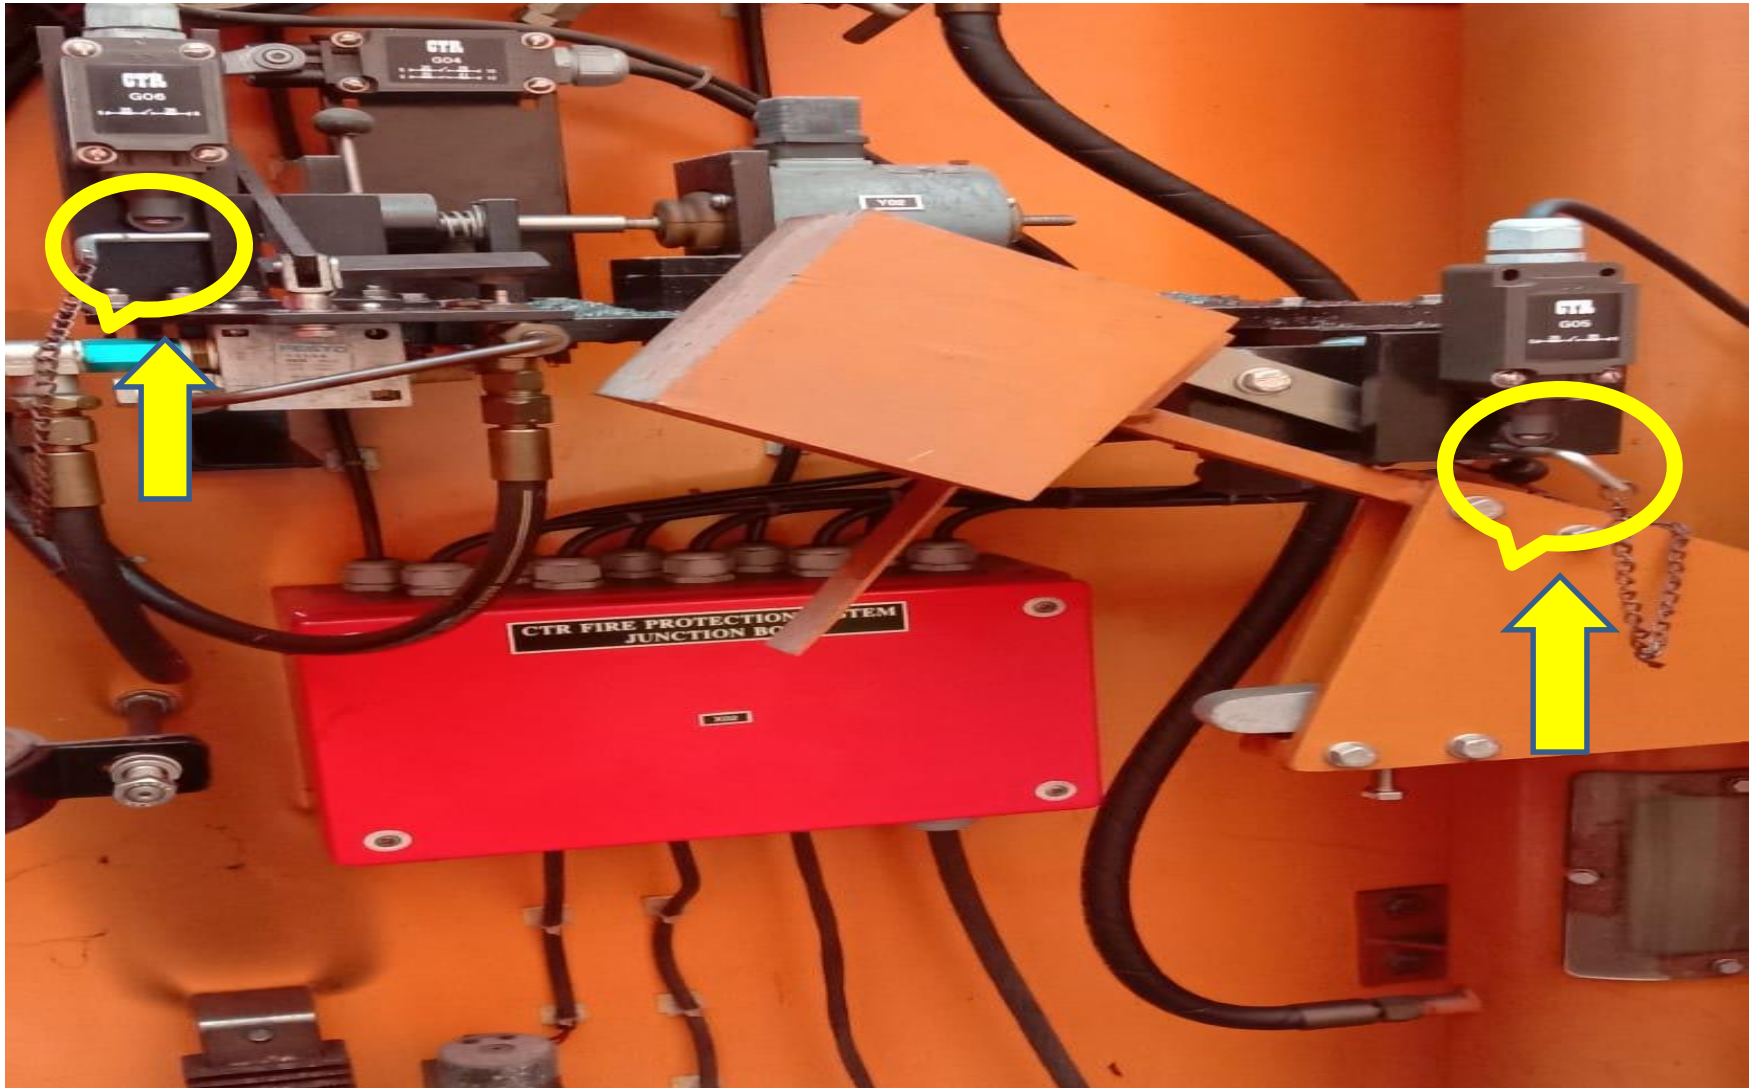
# LOCKING PINS OF NITROGEN INJECTION AND OIL DRAINAGE ARE IN ENGAGED CONDITION

- Whenever locking pin is engaged then an alarm will be displayed in the Control Panel
- Fire Barriers will be installed in other ECR

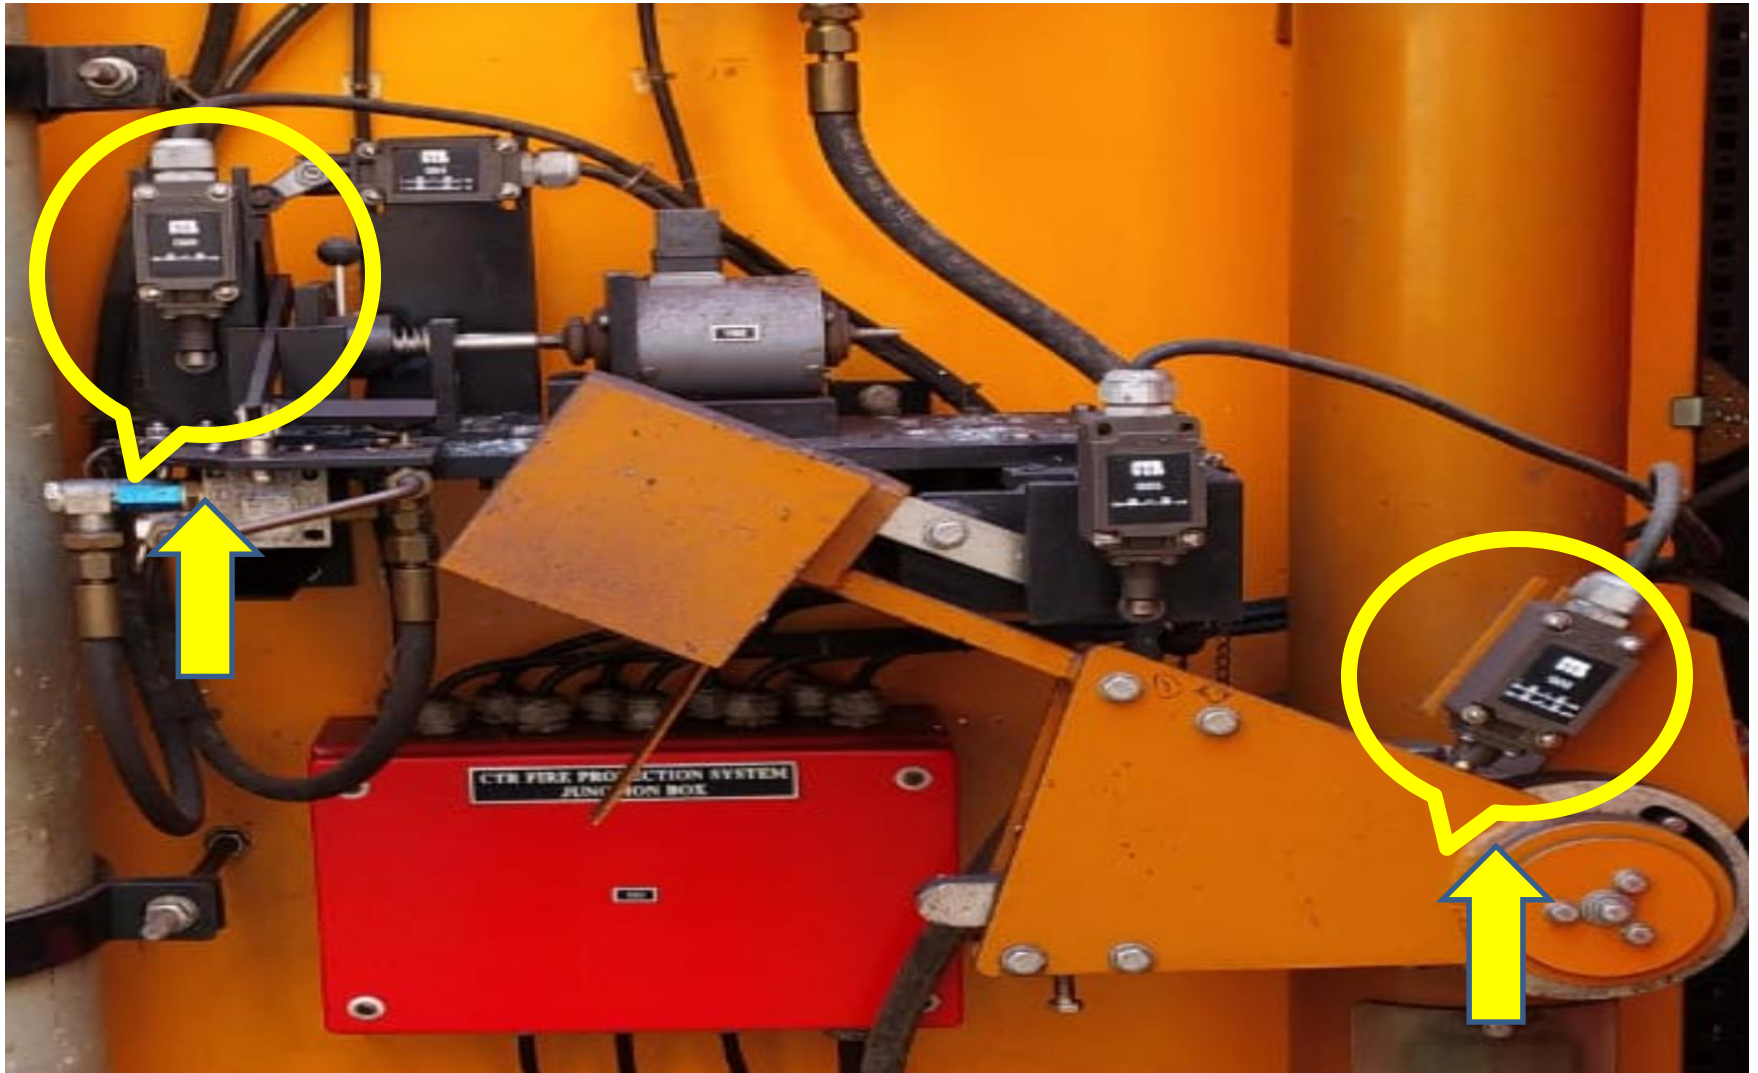
# NITROGEN INJECTION SYSTEM IN ACTIVE MODE
