**ESSAR STEEL INDIA LIMITED, PARADEEP**

**Welcome to the presentation  
on the transformer fire incident that took  
place on 25.10.2012 at PELLET PLANT**

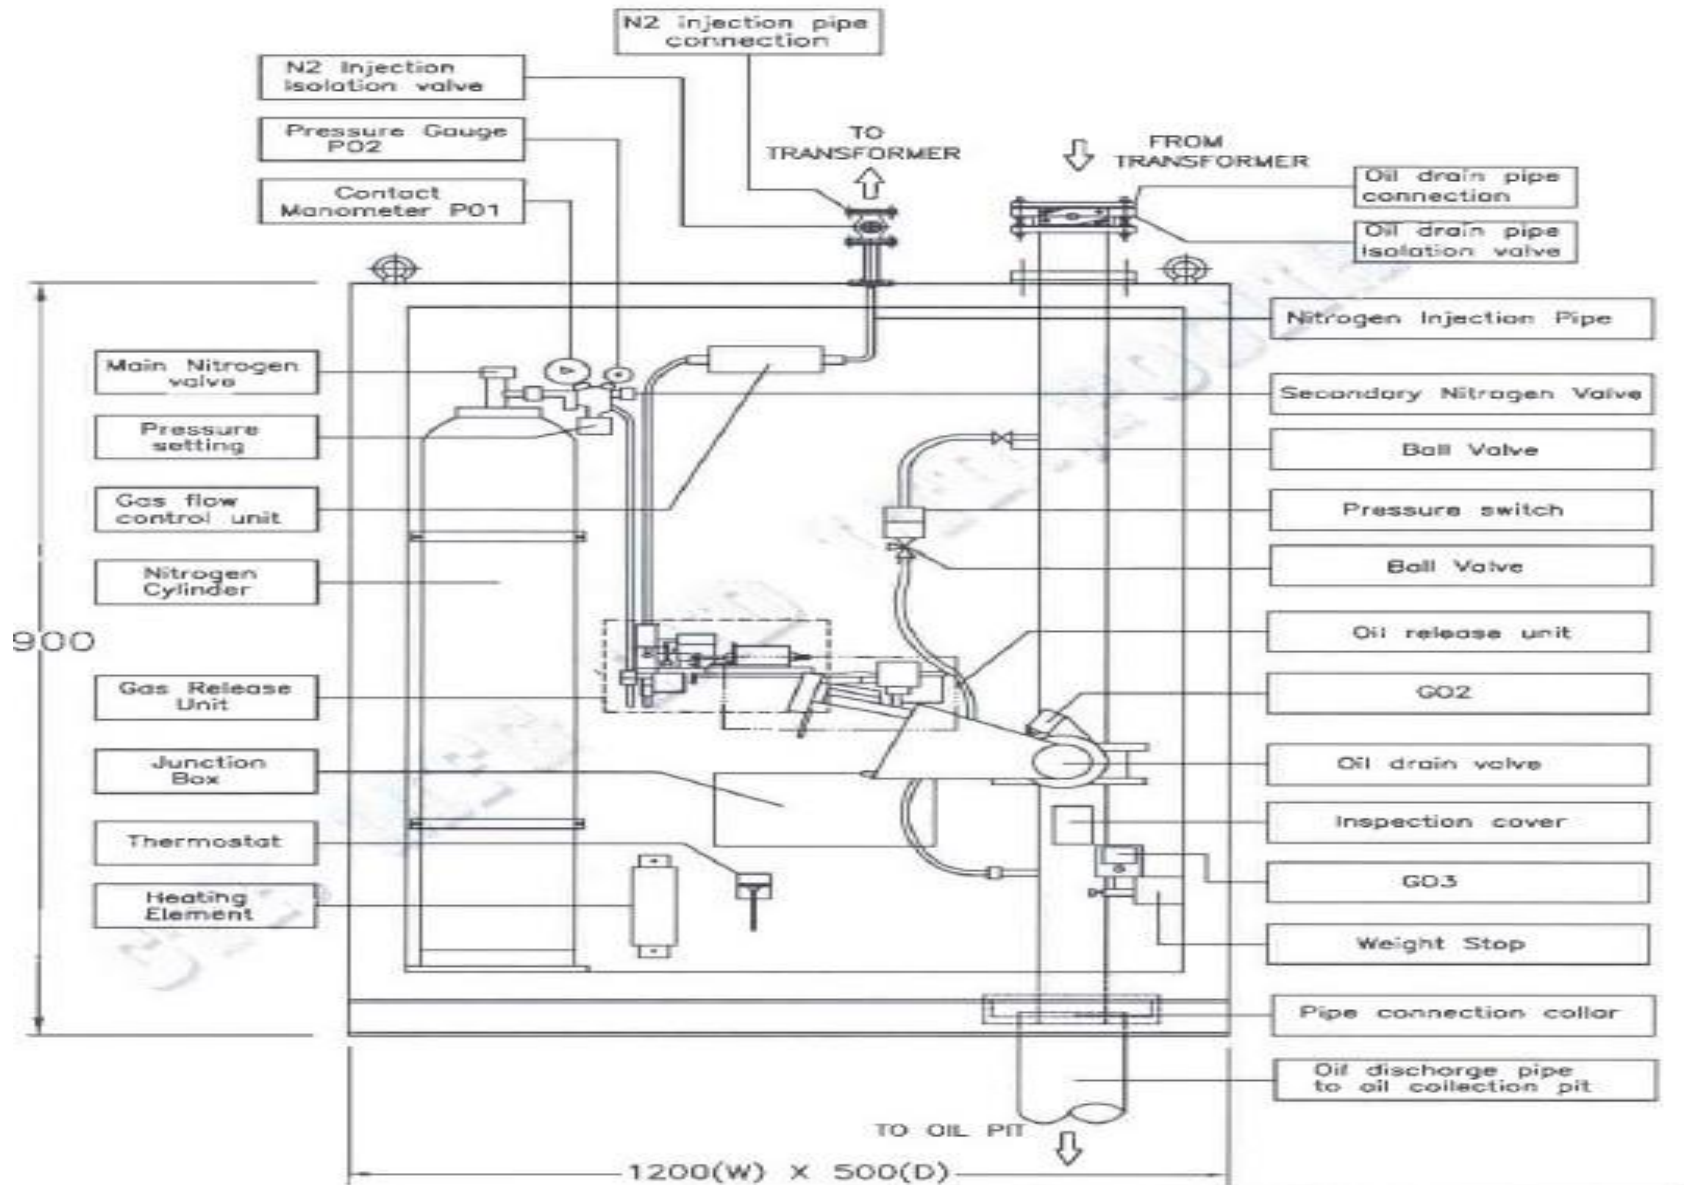
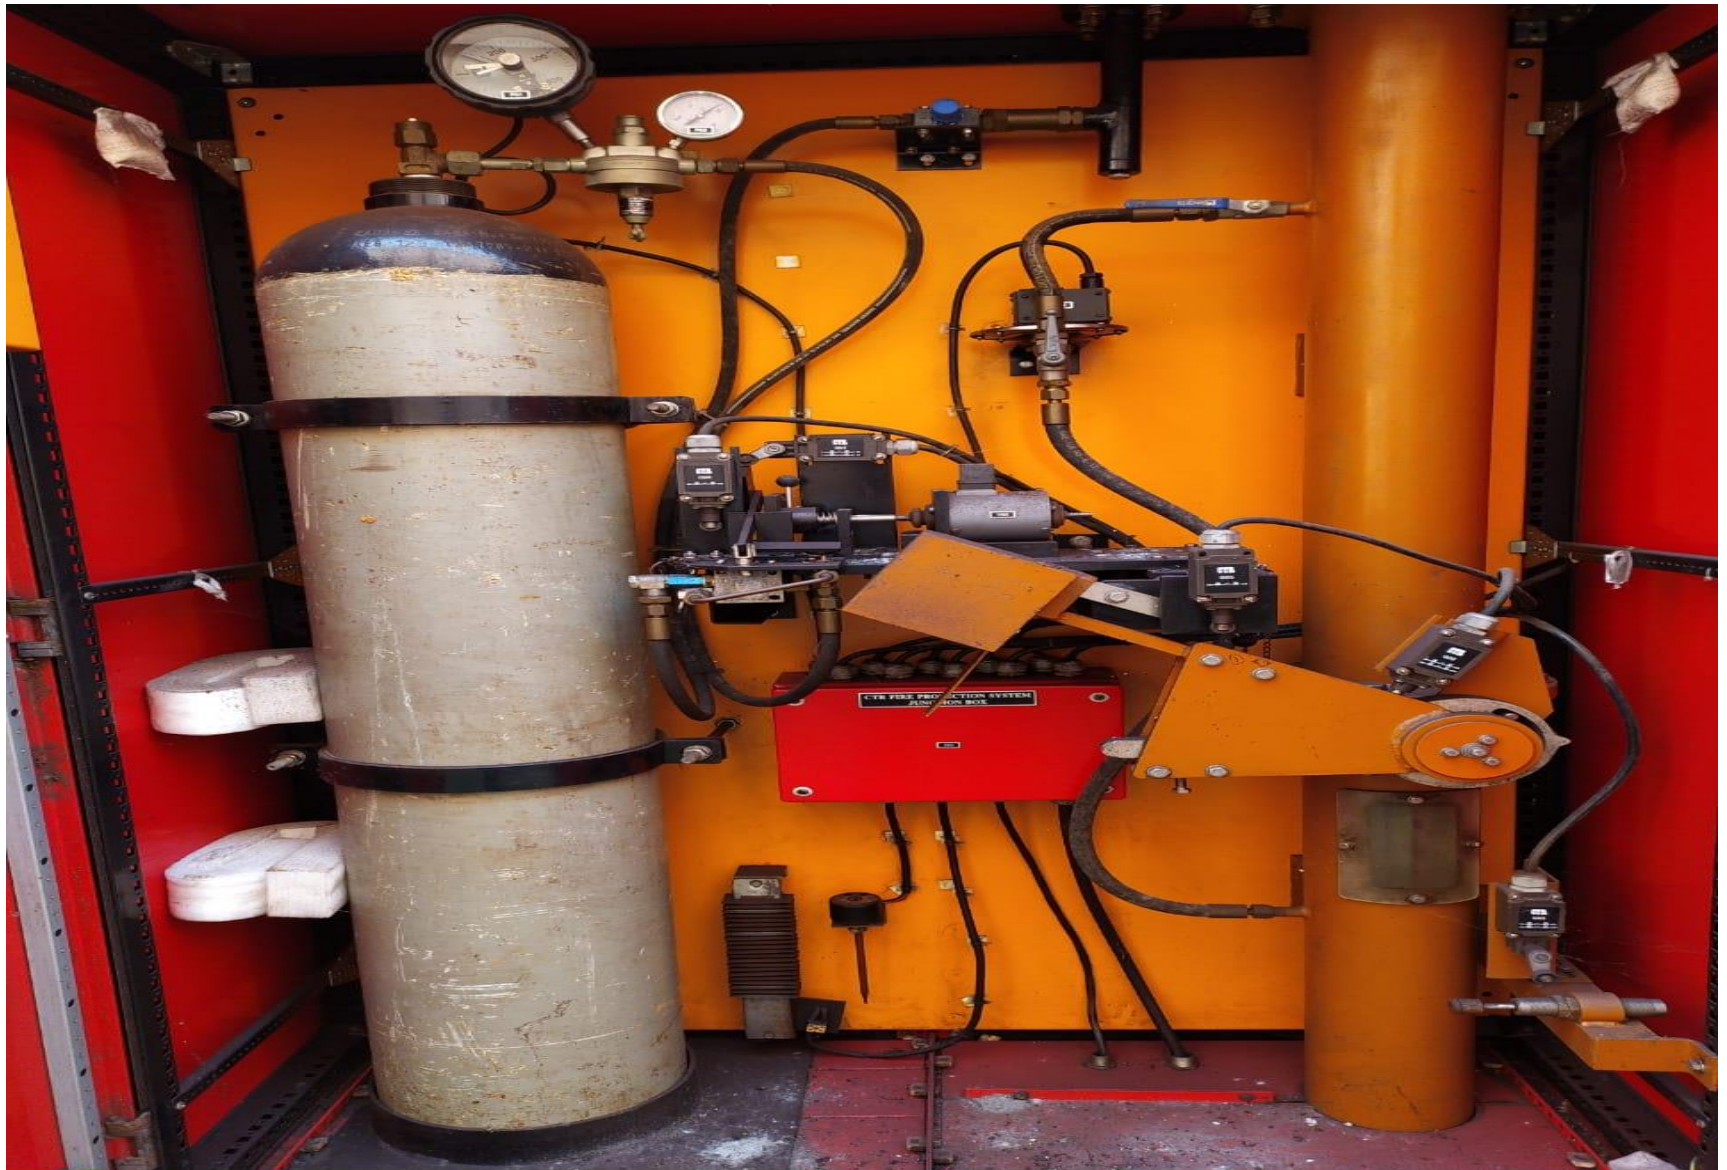
# NITROGEN INJECTION SYSTEM

- The supply voltage from OPTCL's GRID at times was exceeding the rated voltage of 220KV by more than 10% (maximum voltage supplied by OPTCL was recorded to be 250KV)
- Failure of Y-phase EHV bushing of the transformer
- Pre-mature failure of winding of the transformer
- Failure of Nitrogen Injection System as it was in by-pass mode.

- Isolating power dips and supply of excess voltage by tripping the OPTCL line breaker and running the plant in islanding mode with our 2x30 MW Captive Power Plant located adjacent to our Plant
- Putting the Nitrogen Injection System in Active Mode and not in by-pass mode.
