BEST PRACTICES IN SHE

TATA STEEL LONG PRODUCTS LIMITED INNOVATION- FIRST AID TREE

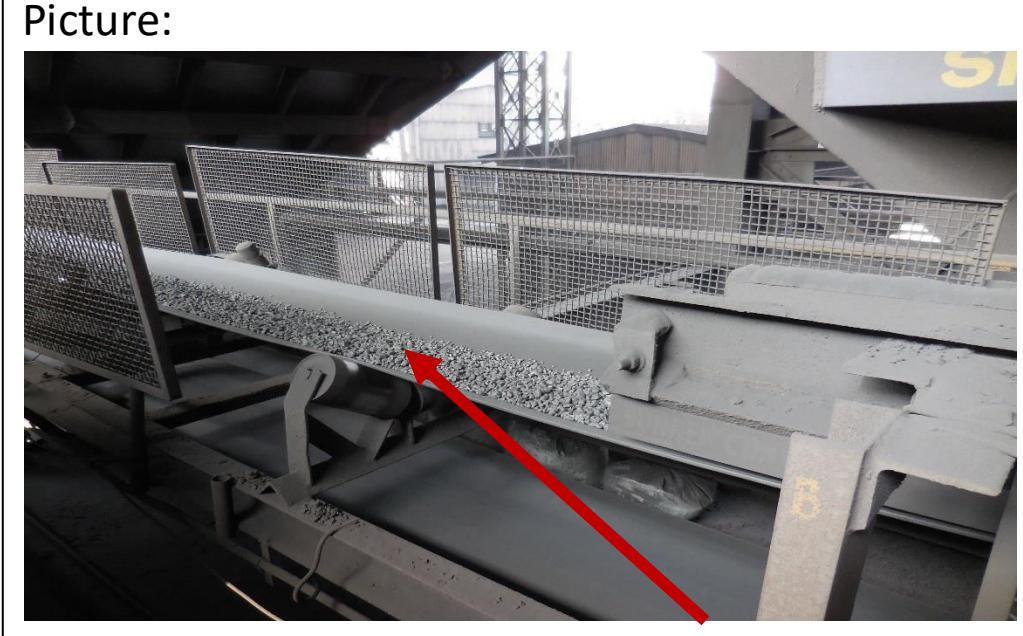
Problem statement::

- 60% observations are reported missing guard from the conveyor
- This was happened due to not fixing the guard after maintenance and housekeeping
- Always there was a threat of an incident during running of the conveyor
- One serious potential Near miss had occurred due to the problem
- Violation of statutory requirement as per Act and Rules

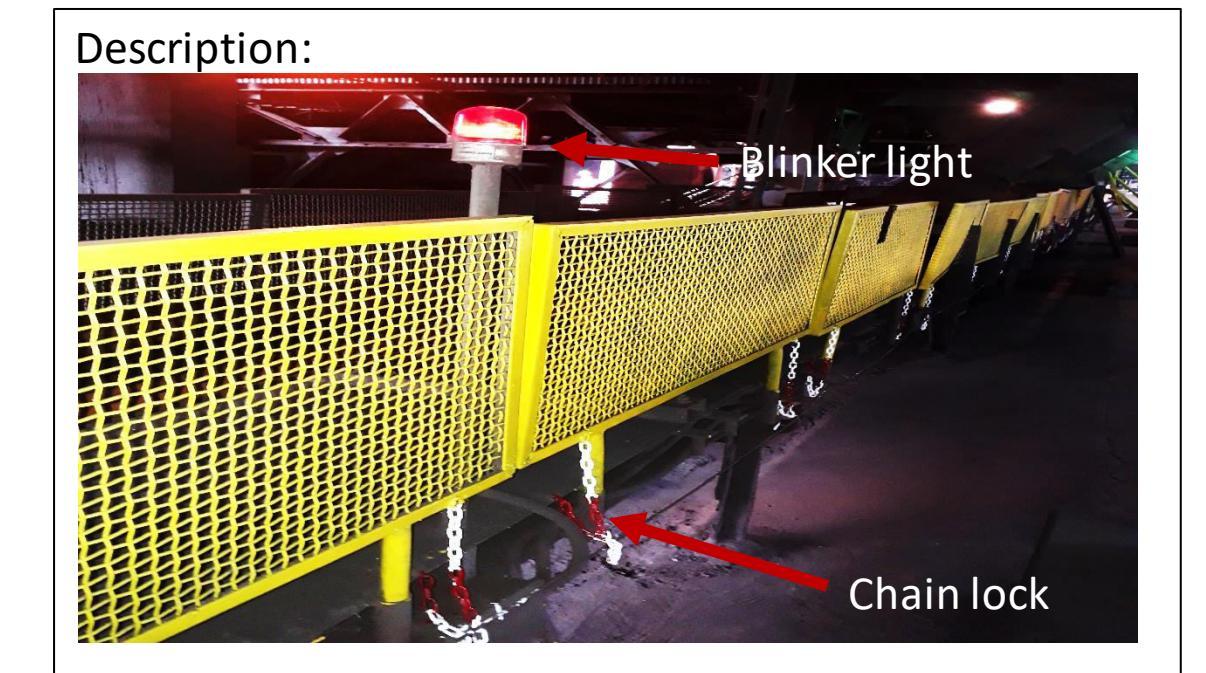
Key benefits::

- 100% conveyor guards are tied with chain lock
- Flash light provision are made to show the running indication of the conveyor
- Miss place of guards are completely eliminated
- 100% comply the statutory requirement
- Unwanted incidents in conveyors are completely eradicated
- Moral of the employee is high

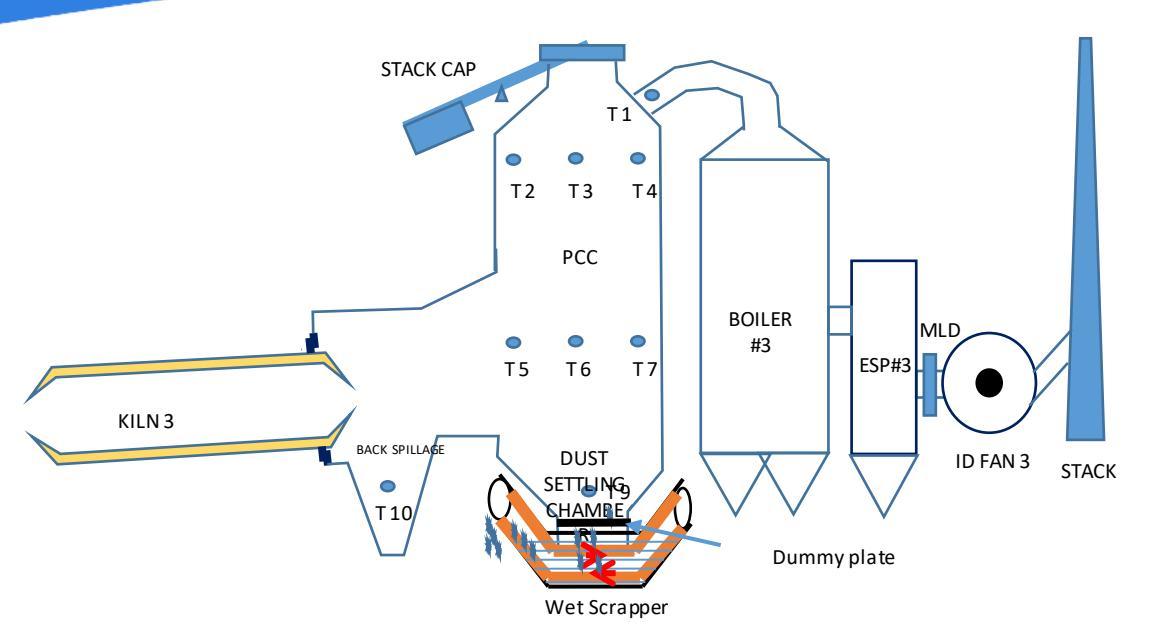
Problem Statement

During any Breakdown in wet scrapper like Chain Snap or heavy material accumulation in the wet scrapper due to PCC Ash Collapse, it is required to fix the dummy plate in its position. During fixing of the dummy plate by chain block and crowbar, there is a possibility of person exposure to hot Flue gas of Around 10000c and hot material fall on the human body, resulting serious burning injury. To execute the job, minimum 3 to 4 persons are required to push the dummy plate.

Risk assessment Score=36

[Scale(2)severity(3)x Probability (3)X Detectability (1)x Duration(2)=36]

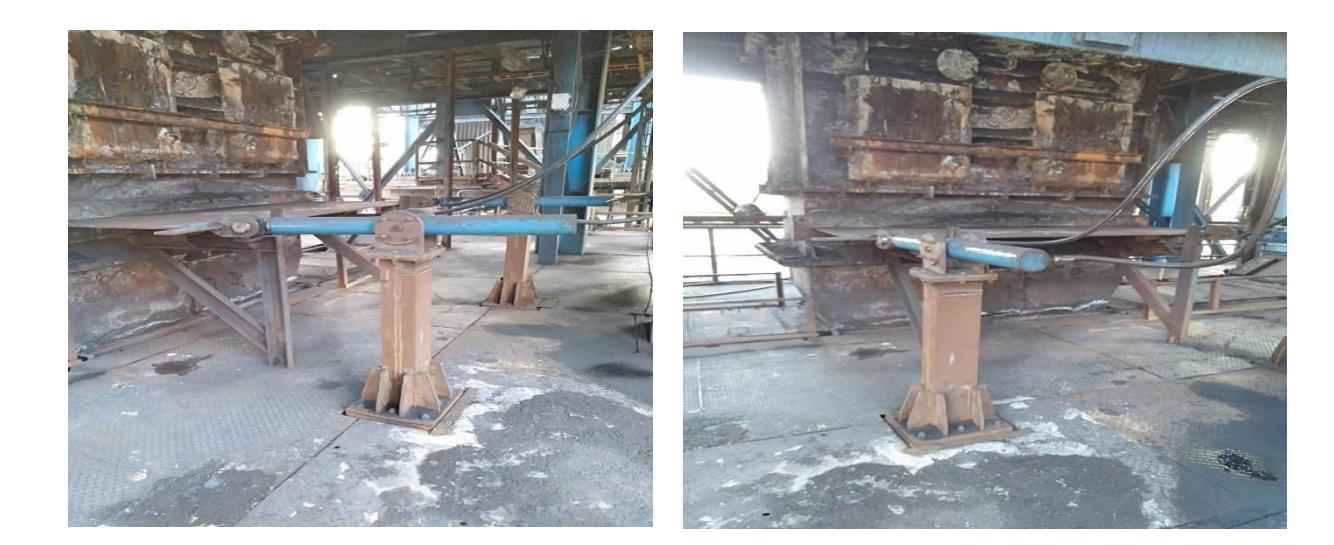
Hydraulic Gate Arrangement: Hydraulic Cylinder assembly to insert and retract the Dummy Plate without any manual intervention

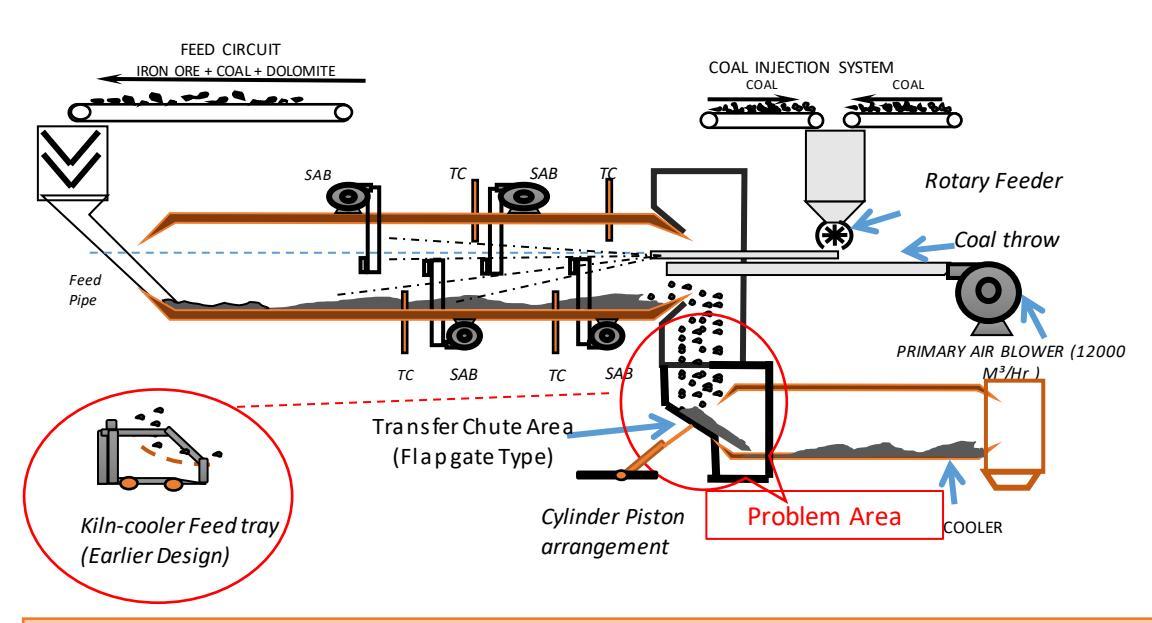
BEFORE

Fi Process Flow Diagram of Sponge Iron Production Facility and Transfer Chute (Flap Gate) area

- Feed Tray Normally weighs 8 to 10MT. During shut down It is required to open the feed tray for fast cooling of Kiln shell and dumping of loose material. So it is done manually through chain blocks
- It normally takes 16hrs for 8 man-power in total for opening and closing the feed tray once in every shut down

Risk assessment Score=81

Scale (3) X Severity (3) X Probability (3) X Detectability (1) X Duration (3) = 81

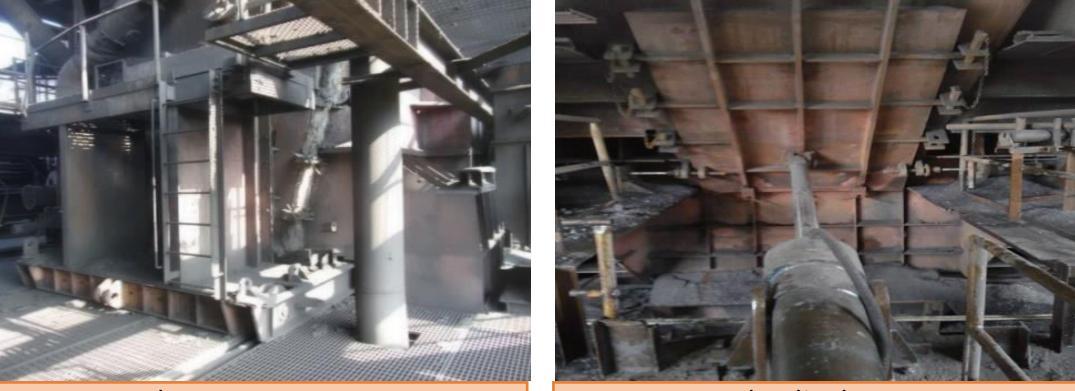
AFTER

Feed Tray arrangement

Hydraulic Flap gate

- Camera Provided near the Transfer Chute at suitable distance for from Flap gate to keep a close control on Opening condition of flap gate without any human intervention at the area.
- Display provided at Control desk in control room.
- Additional Operating facility through Remote Controller from Control room provided to prevent uncontrolled opening of flap gate.
- HIRA and Subsequently SOP modified and People are trained.
- SAB tubes material compositions upgraded with the help of NML, JSR

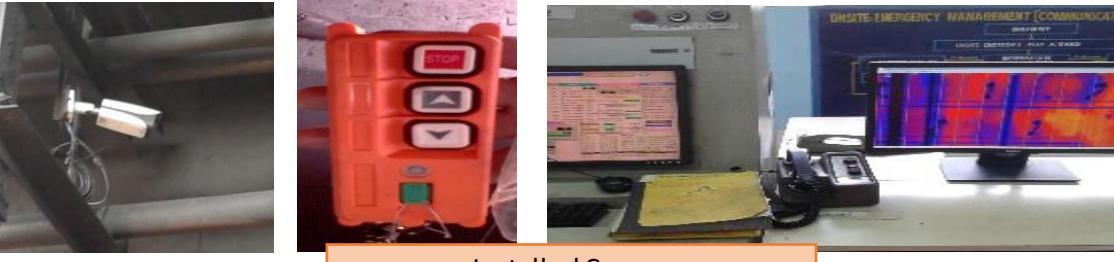
Installed Camera

Risk assessment Score=6

Scale (1) X Severity (3) X Probability (1) X Detectability (1) X Duration (2) = 6

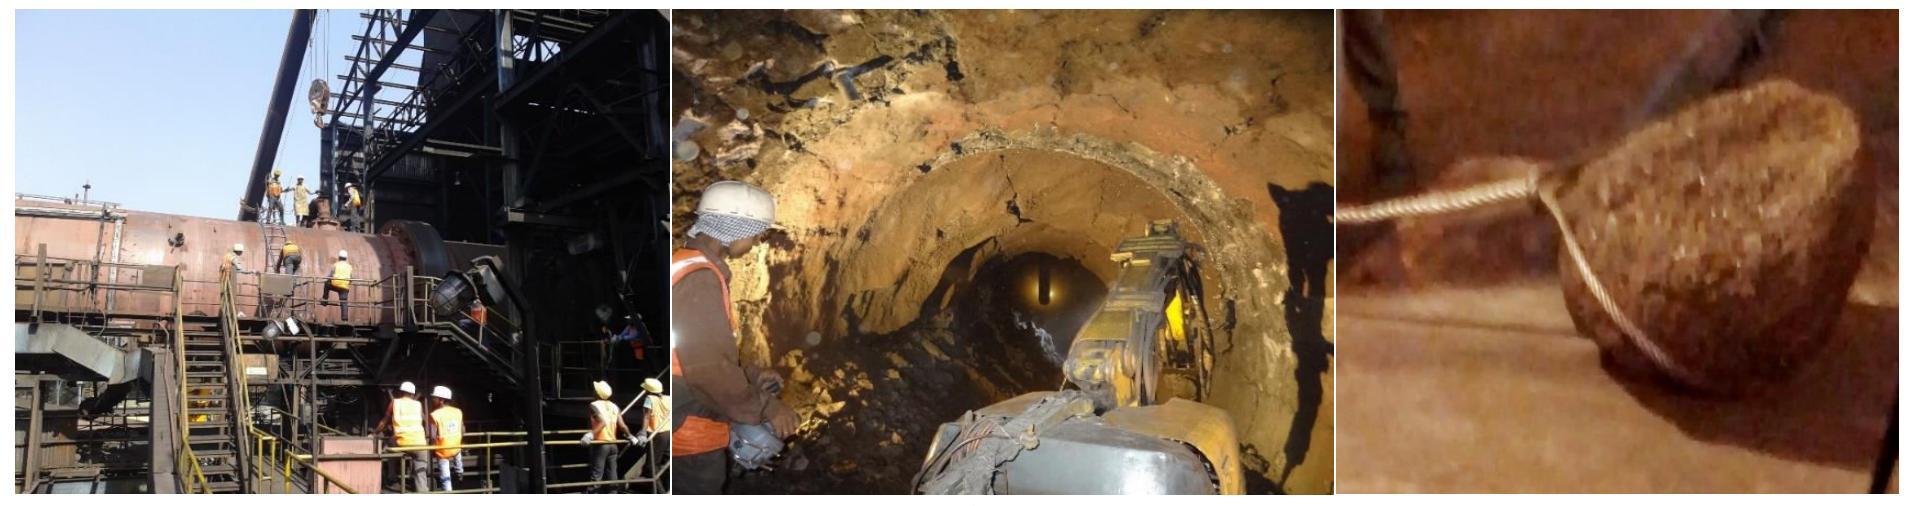
Before

- In every shut down, It normally takes 8-10 days and man power approx. 70-80 involved to complete the activity
- Hazardous activities like, cutting of accretion, Winching of big chunks by manual operated winch machine etc. are going on where the probability of sudden dislodge of accretion piece and winch rope hit to the person may lead to fatal/serious incidents.

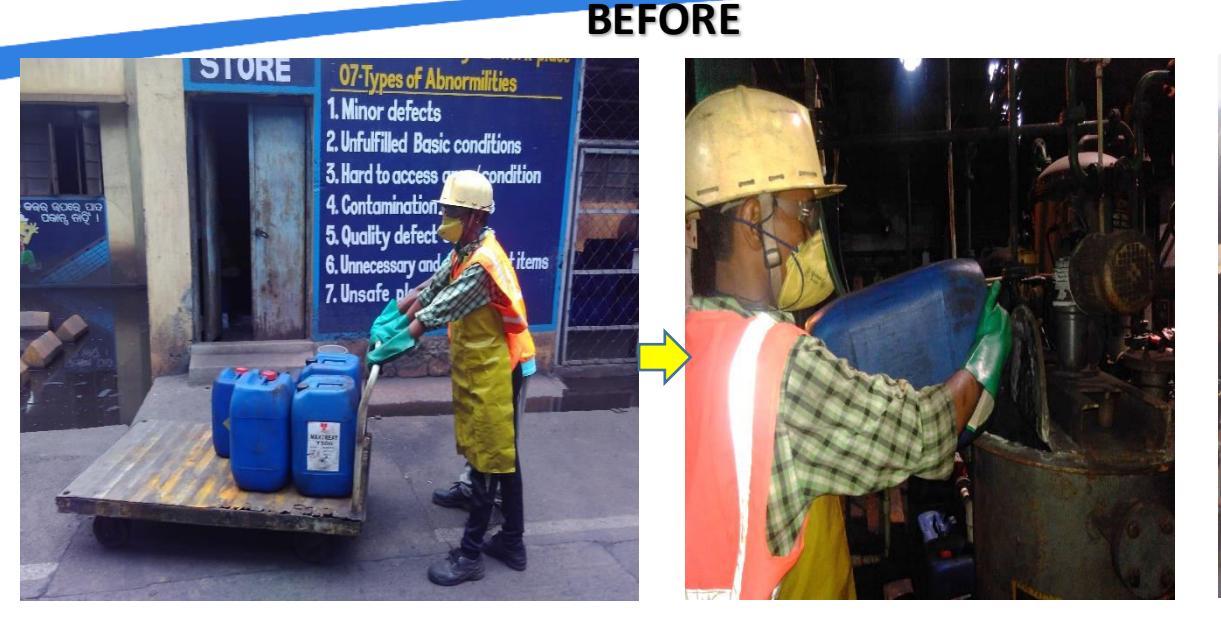
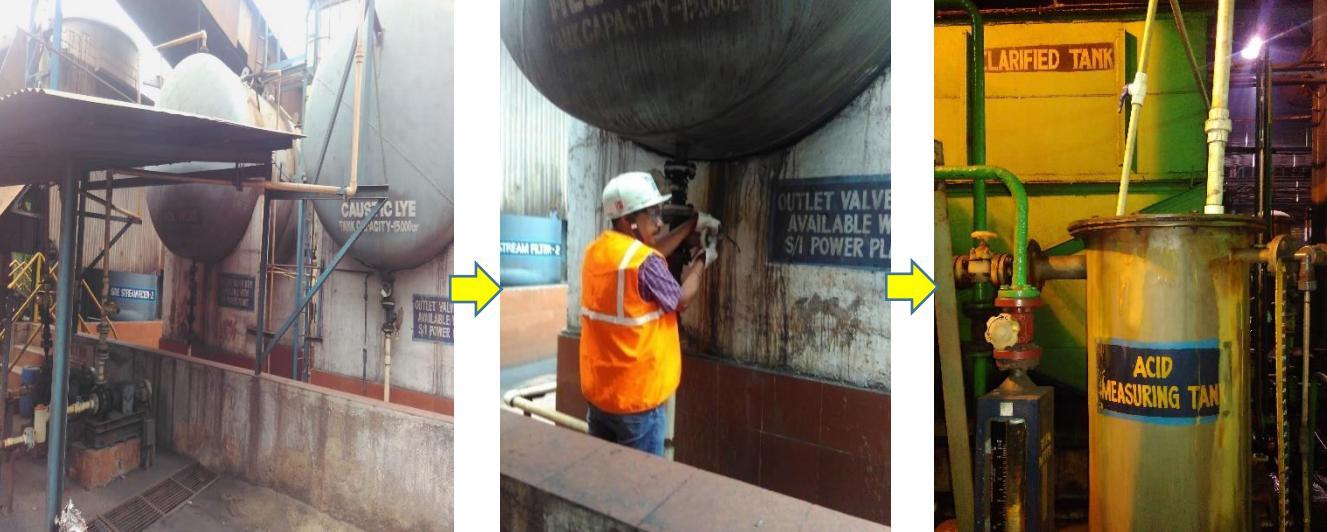
- Manually Acid barrel were transforming from the chemical storage room to DM plant by two person
- Also the activity carried out to feed acid into the acid measuring tank manually by a person.
- Always there was fear to spill of chemical on the ground and also risk to human for exposing to acid
- Risk assessment score: Scale (2) X Severity (3) X Probability (3) X Detectability (2) X Duration (2) = 72

- Acid & Caustic lie storage Tank installed
- Acid & Caustic lie transfer from acid tanker to acid storage tank and subsequently transform to acid measuring tank through pipe.
- Manually activity is completely eliminated and risk reduce to acceptable limit.
- Risk assessment score: Scale (1) X Severity (1) X Probability (3) X Detectability (2) X Duration (2) = 12

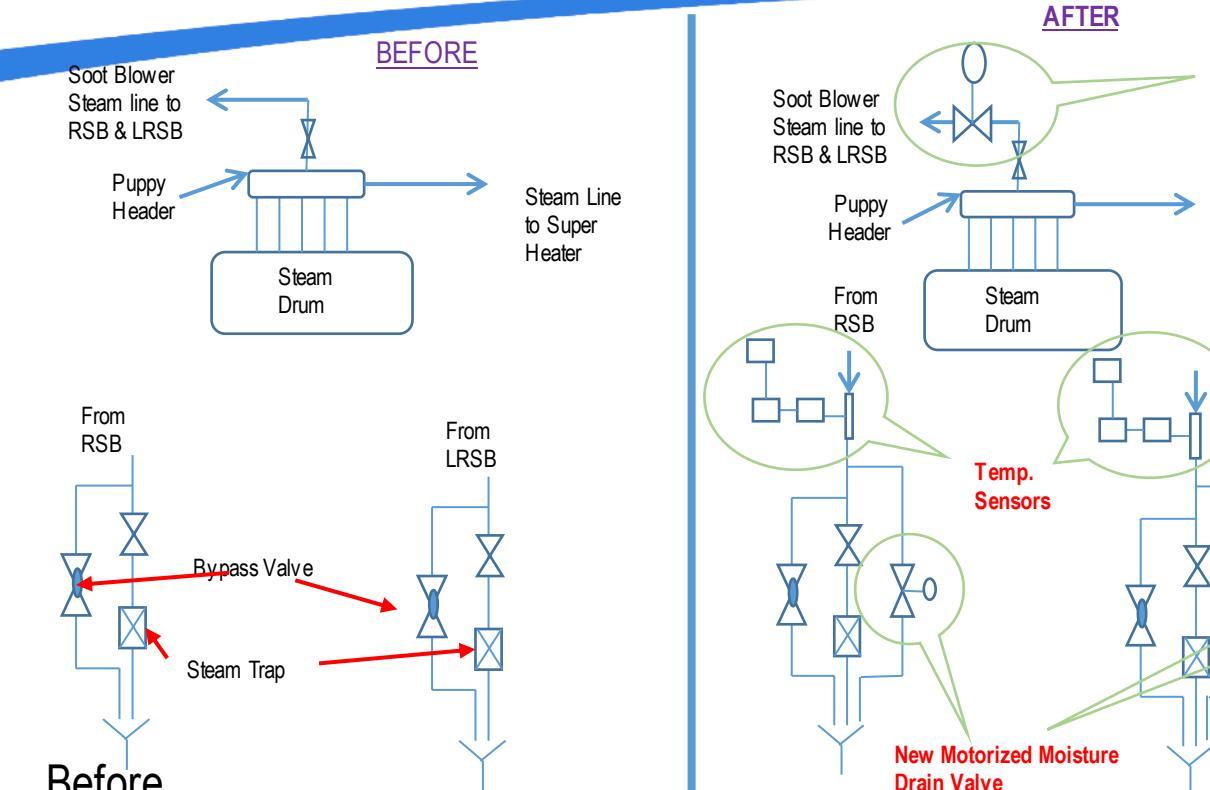
Before

- Whenever Boiler tube got ruptured, It takes minimum 5days 1. to restore and minimum 15 person are involve in this activity.
- 2. Person are working in confined space, work at height and expose to high risk.

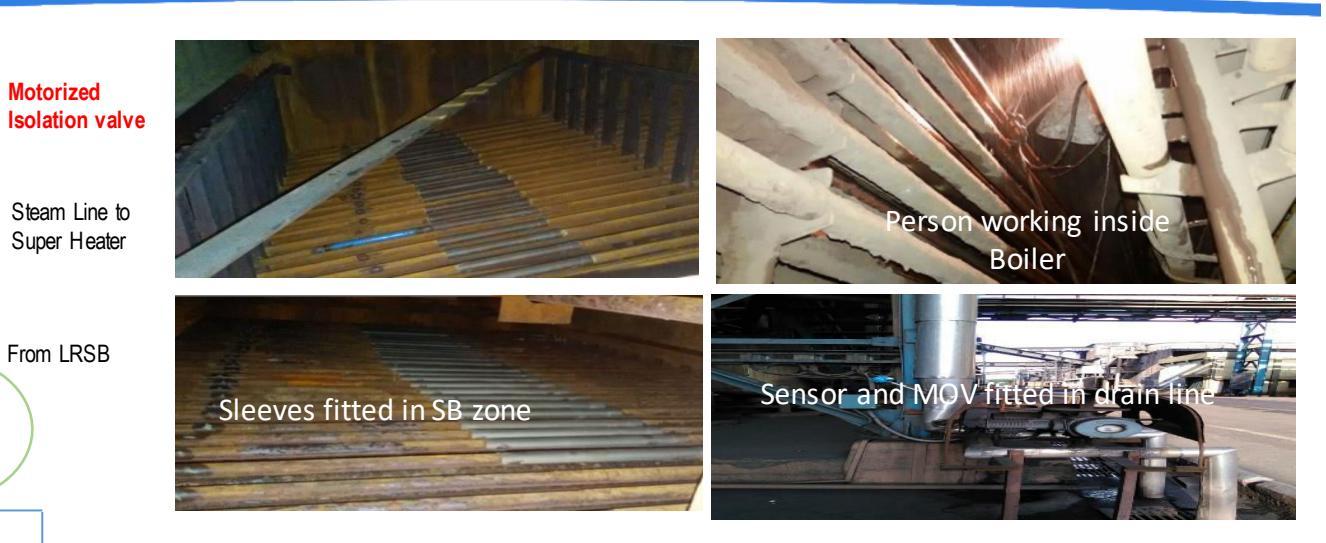
1. Motorized isolation valve installed in between root valve & PCV and Motorized valves installed in individual drain lines.

2. Temperature sensors provided in individual lines. System can be operated from PLC without manual intervention.

3. Install the protection sleeve over the coils of economizer module just below the soot blower's lance tube. At high temp zone LRSV zone material protection sleeve changed from SS-304 to SS-310.

4. After completion of our action, we have found there is no incident of boiler tube failure for last 2 year which ultimately reduce the manual job in the boiler thus reduce the risk
